## Case 269 : Narrative

Case Vehicle (A): 1999 GMC	Vehicle (B): 1997 Honda
Type: Savana, extended cargo van	Type: Civic, 4-door sedan
Driver: 37-year-old male	Driver: 21-year-old male
CDC: 12-FDEW-4	CDC: 99-0000-0

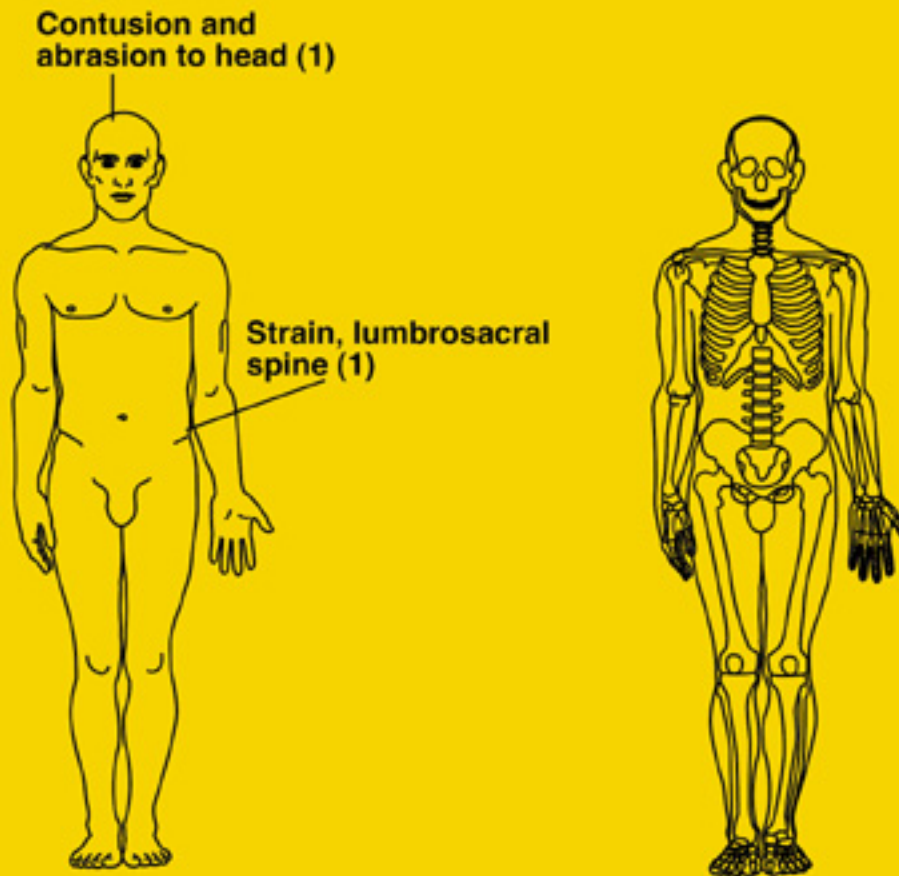
CASE NO.: 269-01

Occupant: Driver	Age: 37 years	Gender: Male		
Restraints: 3-point belt worn; airbag deployed	Stature: 178 cm (5 ft, 10 in)	Mass: 82 kg (180 lb)		
Injury Description	A.I.S.	Injury Source		
—	—	Definite	Probable	Possible
Contusion, head	1	—	Side window	—
Abrasion, head	1	—	Side window	—
Strain, lumbrosacral spine	1	—	Impact forces	—
Maximum A.I.S. Level	1	—	—	—
Injury Severity Score	2	—	—	—

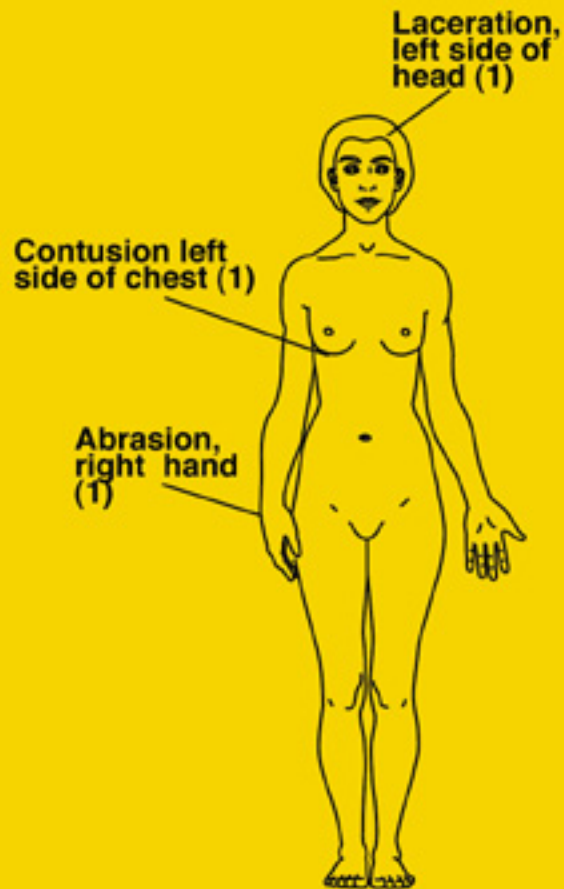
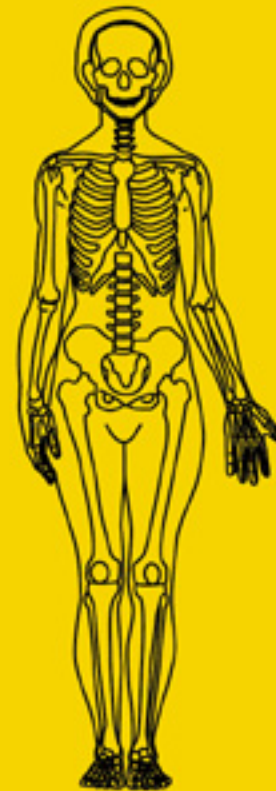
CASE NO.: 269-01

Occupant: Center front	Age: 48 years	Gender: Female		
Restraints: 3-point belt and airbag not available	Stature: 165 cm (5 ft, 5 in)	Mass: 54 kg (120 lb)		
Injury Description	A.I.S.	Injury Source		
—	—	Definite	Probable	Possible
Laceration, left side of head	1	—	Center instrument panel	—
Contusion, left side of chest	1	—	Center instrument panel	—
Abrasion, right hand	1	—	Center instrument panel	—
Maximum A.I.S. Level	1	—	—	—
Injury Severity Score	1	—	—	—

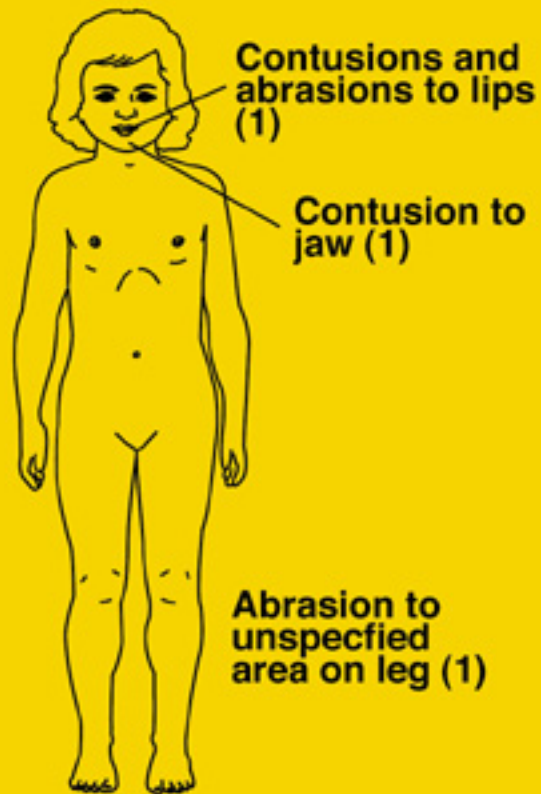
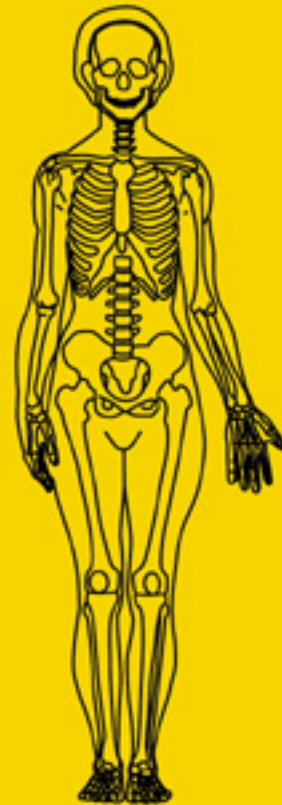
CASE NO.: 269-01

Occupant: Right front	Age: 9 years	Gender: Female		
Restraints: 3-point belt worn; airbag deployed	Stature: 122 cm (4 ft, 0 in)	Mass: 25 kg (60 lb)		
Injury Description	A.I.S.	Injury Source		
—	—	Definite	Probable	Possible
Contusion, lips	1	—	Airbag	—
Abrasion, lips	1	—	Airbag	—
Contusion, jaw	1	—	Airbag	—
Abrasion, lower leg	1	—	Airbag	—
Maximum A.I.S. Level	1	—	—	—
Injury Severity Score	1	—	—	—

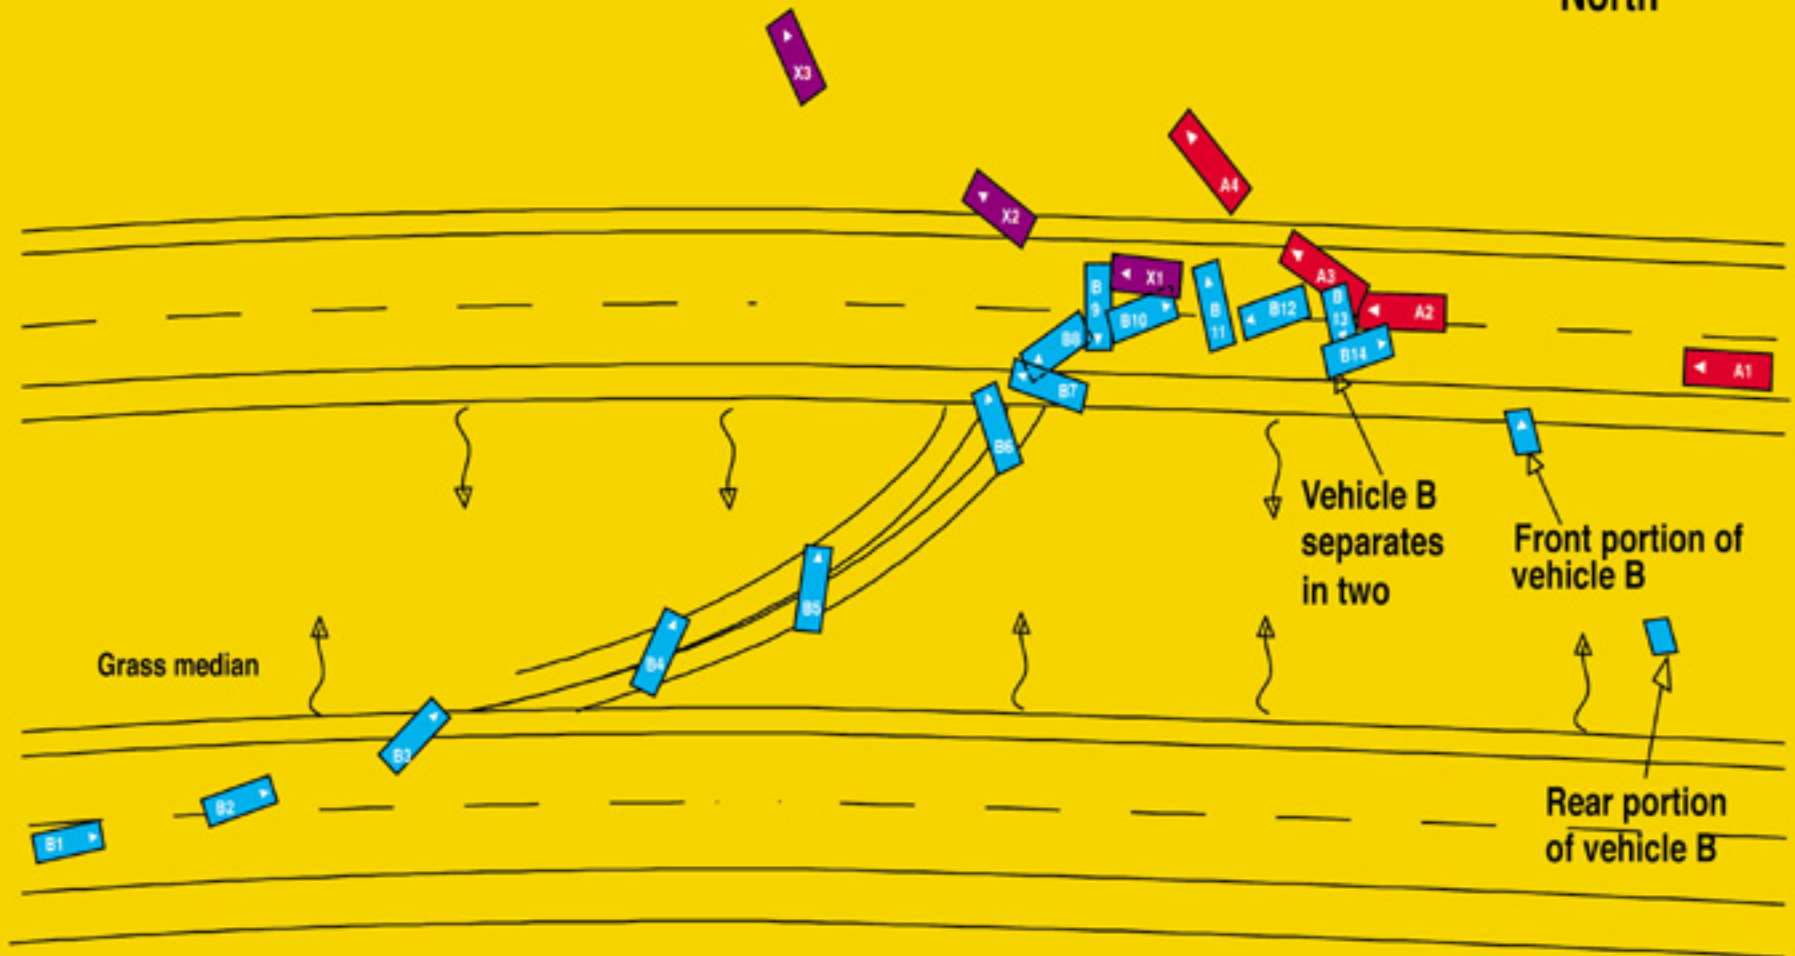
Case No.: 269-01  
Veh. (A): 1999 GMC  
Type: Savana, extended cargo van  
Driver: 37-year-old male  
Veh. (B): 1997 Honda Civic, 4-door sedan

1 Case vehicle (A) was traveling west in the inside westbound lane of a four-lane divided highway. Vehicle (X) was traveling west in the outside westbound lane of the same roadway ahead of case vehicle (A). Vehicle (B) was traveling east in the outside eastbound lane of the same roadway. It was daylight and cloudy, and the roadway was dry and in good condition.

2 The driver of vehicle (B) reportedly fell asleep and vehicle (B) departed the roadway off the north shoulder of the eastbound lanes. As vehicle (B) entered the grass median, it began to rotate counterclockwise as it traversed the median. As vehicle (B) approached the south shoulder of the westbound travel lanes, it became airborne and entered the path of vehicle (X) with the rear end facing north. The front of vehicle (X) struck the left side of vehicle (B). Vehicle (B) continued to rotate counterclockwise as it separated from vehicle (X) and entered the path of case vehicle (A). The driver of case vehicle (A) attempted to avoid a collision by veering to the right but was unable to do so. The front of case vehicle (A) struck the left side of vehicle (B). The impact caused case vehicle (A) to enter a clockwise rotation and depart the roadway off of the north shoulder before it came to rest on the north side of the westbound lanes. After the second left-side impact, vehicle (B) separated into two pieces. The front portion of the vehicle came to rest facing north, straddling the south shoulder of the westbound lanes and the median. The rear portion of vehicle (B) came to rest near the middle of the median. The driver, center-front, and right-front passengers of case vehicle (A) were transported to a local hospital for treatment. The

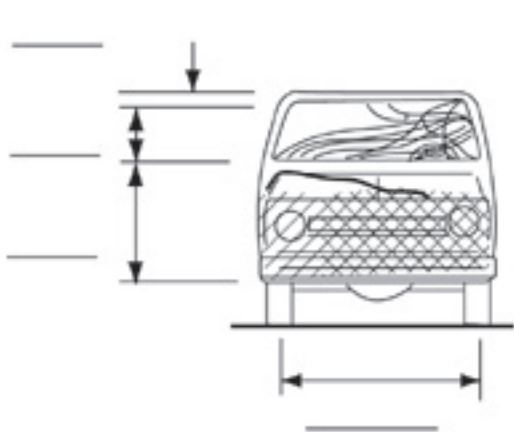
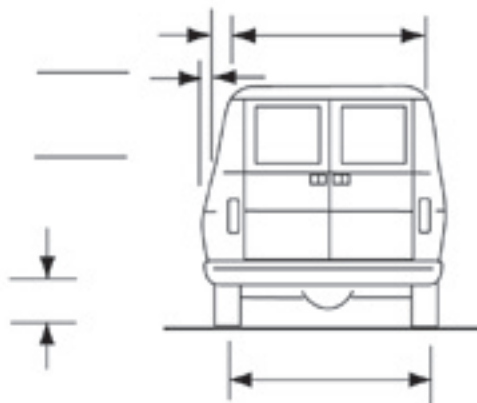
Direct damage = 150 cm

Max crush = 50 cm

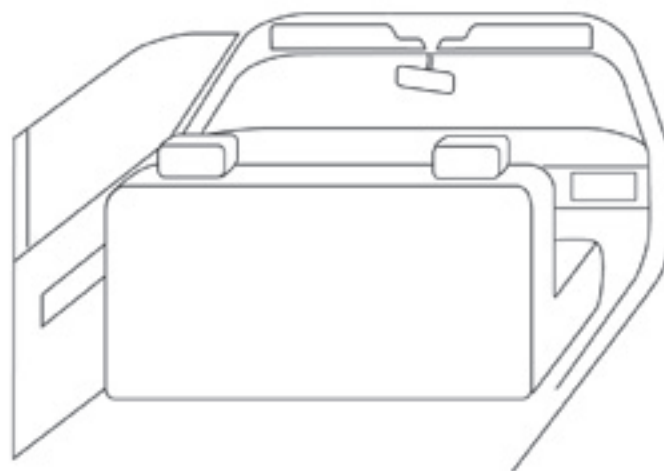
**Instrument panel dislodged**
